**Flood Control Project Maintenance
Levee Inspections**
LMA District Cover Sheet
Spring 2018 Levee Inspection Results

Reclamation District No. 2060 Hastings

Spring 2018 Levee Inspection Results

Waterway			Bank	Unit Miles
Unit No. 01 Lindsey Slough			Left	6.97
	Spring (March - May)	Summer (June - August)	(September - November) Fall	Winter (December - February)
Unit Maintenance Rating (Fall Only)				
Date of Inspection	3/28/2018 - 3/28/2018			
DWR Inspector	Keith Millard			
Accompanied By	Mark Boyd RD 2060 Hastings Tract			
	Michael Moncrief MBK Engineers			
	Jack Kuechler RD 2060

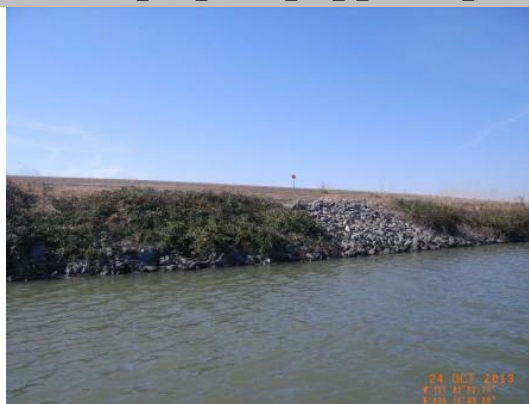
Photo 1 of 1 : SP_2018_RD2060_243_4_20180305_00004.jpg

LM Start	2.35	Rating **	A/W	Issue No.	4
LM End	2.53	Issue Type +	Ma	Location *	WS
Category	Supplemental			GPS Latitude/Longitude	
				Start	End
Item	2015 USACE Erosion Survey, DRAFT			38.280377 °	38.278306 °
				-121.714633 °	-121.712722 °
DWR ID	DWR_RD2060_03_s_2016_4				
Comment Code					
Inspector Comment					
2008 - Small scour pockets and mid-slope wave wash. 2010 - More vegetation growth, could be fixed through maintenance. 2011 - Site extended downstream and new erosion. 2015: No observed changes. [2015 Site ID: CHS_22-6_R]

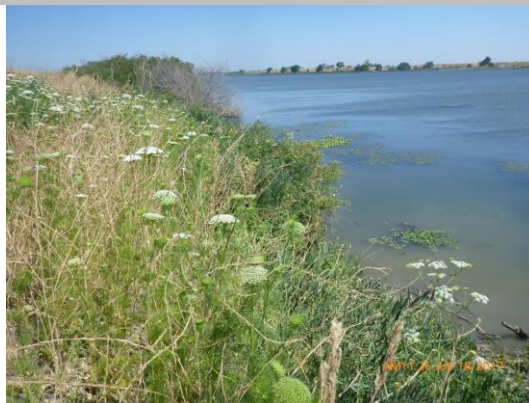
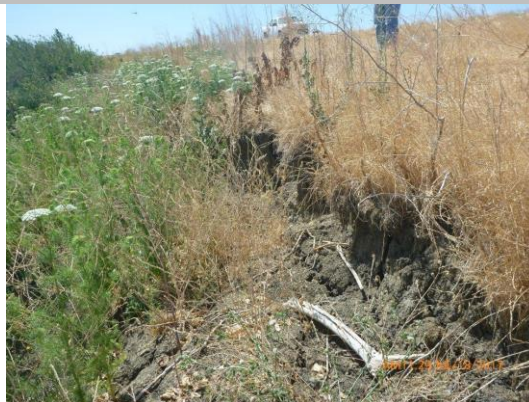
LM Start	2.47	Rating **	M	Issue No.	32 (cont)	
LM End	2.49	Issue Type +	Ma	Location *		
Category	Supplemental			GPS Latitude/Longitude		
				Start		End
Item	2017 Storm Damage			38.278794 °		38.278533 °
				-121.713703 °		-121.713453 °
DWR ID	DWR_RD2060_03_f _ 2017_32					
Comment Code						
Inspector Comment						
Levee Evaluation Comments						
Description:Erosion commences approximately halfway down the slope and results in sloughing into the waterside toe.						
Site ID No:401						
Site Designation:LMA-228						
Repair Type: Erosion						
Rating:Area of Concern						
Field Date:7/18/2017						
Notes: Erosion and sloughing. Heavy veg flanking both sides.

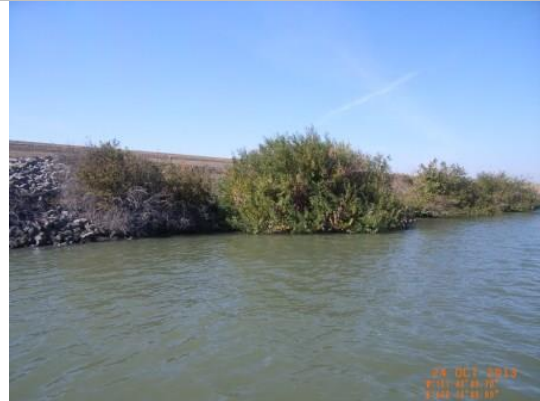
Photo 1 of 1 : SP_2018_RD2060_243_5_20180305_00005.jpg

LM Start	2.55	Rating **	A/W	Issue No.	5
LM End	2.58	Issue Type +	Ma	Location *	WS
Category	Supplemental			GPS Latitude/Longitude	
				Start	End
Item	2015 USACE Erosion Survey, DRAFT			38.278145 °	38.277774 °
				-121.712609 °	-121.712137 °
DWR ID	DWR_RD2060_03_s_2016_5				
Comment Code					
Inspector Comment					
2013 - Erosion pockets into the levee toe. 2015: Erosion pockets have increased in size. [2015 Site ID: CHS_22-5_R]

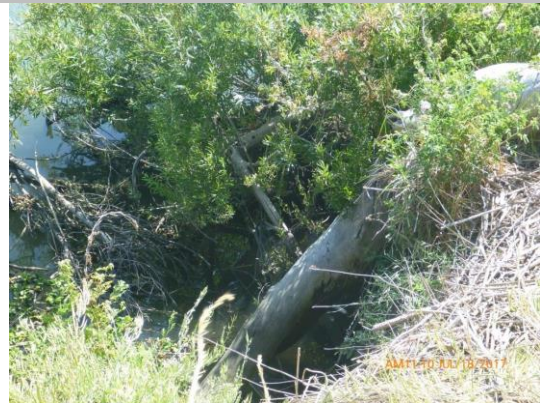
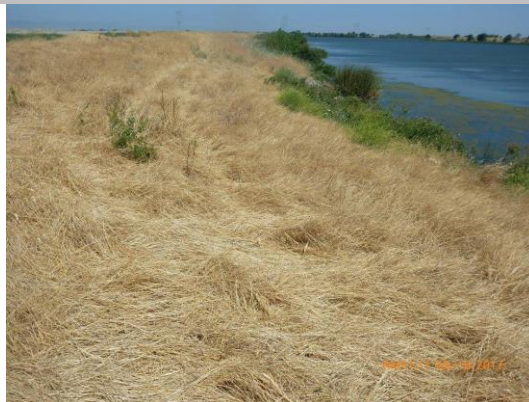
LM Start	2.55	Rating **	M	Issue No.	33
LM End	2.55	Issue Type +	Ma	Location *	
Category	Supplemental			GPS Latitude/Longitude	
				Start	End
Item	2017 Storm Damage			38.277956 °	38.277928 °
				-121.712814 °	-121.712775 °
DWR ID	DWR_RD2060_03_f_2017_33				
Comment Code					
Inspector Comment					
Levee Evaluation Comments					
Description:Erosion commences approximately halfway down the slope and extends to the waterside toe.					
Site ID No:402					
Site Designation:LMA-229					
Repair Type: Erosion					
Rating:Area of Concern					
Field Date:7/18/2017					
Notes: Small but deep vertical cut down to water.

LM Start	2.55	Rating **	M	Issue No.	33 (cont)
LM End	2.55	Issue Type +	Ma	Location *	
Category	Supplemental			GPS Latitude/Longitude	
				Start	End
Item	2017 Storm Damage			38.277956 °	38.277928 °
				-121.712814 °	-121.712775 °
DWR ID	DWR_RD2060_03_f_2017_33				
Comment Code					
Inspector Comment					
Levee Evaluation Comments					
Description:Erosion commences approximately halfway down the slope and extends to the waterside toe.					
Site ID No:402					
Site Designation:LMA-229					
Repair Type: Erosion					
Rating:Area of Concern					
Field Date:7/18/2017					
Notes: Small but deep vertical cut down to water.

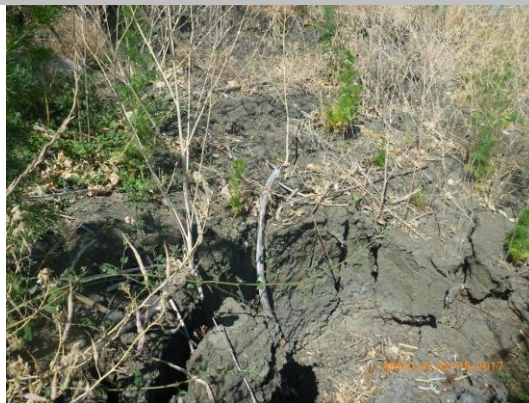
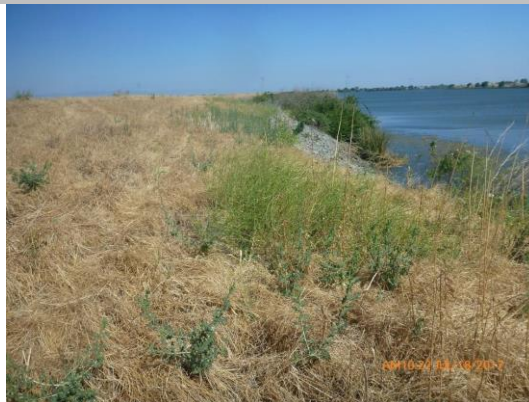
LM Start	2.64	Rating **	M	Issue No.	35 (cont)	
LM End	2.64	Issue Type +	Ma	Location *		
Category	Supplemental			GPS Latitude/Longitude		
				Start		End
Item	2017 Storm Damage			38.277106 °		38.277078 °
				-121.711489 °		-121.711447 °
DWR ID	DWR_RD2060_03_f _ 2017_35					
Comment Code						
Inspector Comment						
Levee Evaluation Comments						
Description:Erosion commences approximately 1/4 of the way down the slope and results in sloughing into the waterside toe.						
Site ID No:404						
Site Designation:LMA-231						
Repair Type: Erosion						
Rating:Area of Concern						
Field Date:7/18/2017						
Notes: Small erosion and sloughing adjacent to revetted slope.

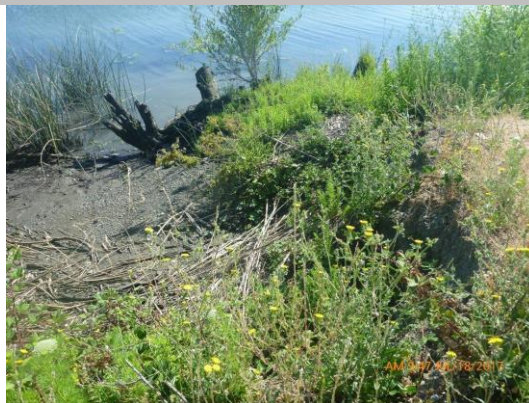
Photo 3 of 3 : SP_2018_RD2060_243_36_20180305_00069.jpg

LM Start	2.69	Rating **	A/W	Issue No.	36 (cont)	
LM End	2.73	Issue Type +	Ma	Location *		
Category	Supplemental			GPS Latitude/Longitude		
				Start	End	
Item	2017 Storm Damage			38.276608 °	38.276133 °	
				-121.710811 °	-121.710394 °	
DWR ID	DWR_RD2060_03_f _ 2017_36					
Comment Code						
Inspector Comment						
Levee Evaluation Comments						
Description:Sloughing commences approximately halfway down the slope and extends to the waterside toe.						
Site ID No:405						
Site Designation:LMA-232						
Repair Type: Erosion						
Rating:Serious						
Field Date:7/18/2017						
Notes: Vertical cut at highwater mark.

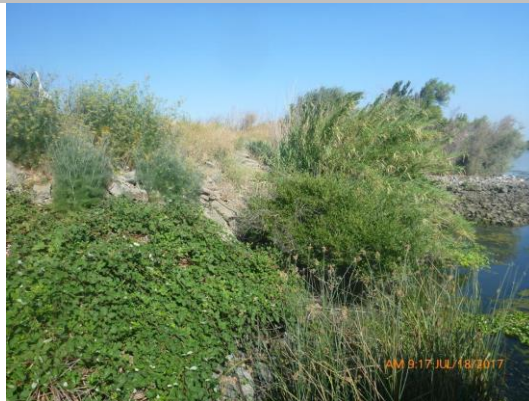
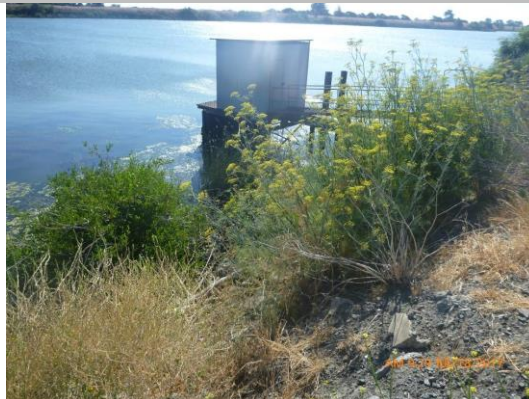
LM Start	3.24	Rating **	M	Issue No.	37
LM End	3.24	Issue Type +	Ma	Location *	
Category	Supplemental			GPS Latitude/Longitude	
				Start	End
Item	2017 Storm Damage			38.270231 °	38.270203 °
				-121.705897 °	-121.705856 °
DWR ID	DWR_RD2060_03_f_2017_37				
Comment Code					
Inspector Comment					
Levee Evaluation Comments					
Description:Erosion commences approximately halfway down the slope and results in sloughing into the waterside toe. Existing rip rap has been pulled off the slope at this site.					
Site ID No:406					
Site Designation:LMA-233					
Repair Type: Erosion					
Rating:Area of Concern					
Field Date:7/18/2017					
Notes: Erosion is next to a pumphouse and slope is protected withrip rap.

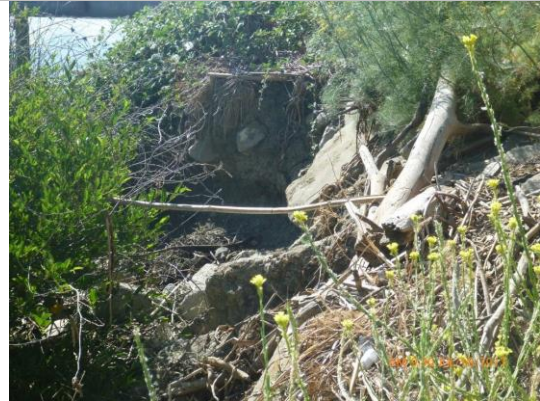
Photo 3 of 3 : SP_2018_RD2060_243_37_20180305_00072.jpg

LM Start	3.24	Rating **	M	Issue No.	37 (cont)	
LM End	3.24	Issue Type +	Ma	Location *		
Category	Supplemental			GPS Latitude/Longitude		
				Start	End	
Item	2017 Storm Damage			38.270231 °	38.270203 °	
				-121.705897 °	-121.705856 °	
DWR ID	DWR_RD2060_03_f_2017_37					
Comment Code						
Inspector Comment						
Levee Evaluation Comments						
Description:Erosion commences approximately halfway down the slope and results in sloughing into the waterside toe. Existing rip rap has been pulled off the slope at this site.						
Site ID No:406						
Site Designation:LMA-233						
Repair Type: Erosion						
Rating:Area of Concern						
Field Date:7/18/2017						
Notes: Erosion is next to a pumphouse and slope is protected withrip rap.

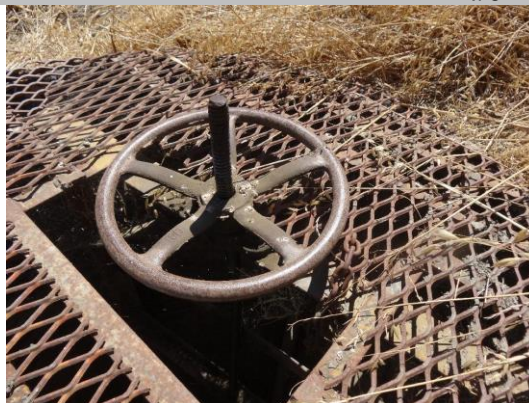
Photo 2 of 3 : UCIP_SP_2018_18723_31302.jpg

LM Start	3.24	Rating **	M	Issue No.	74 (cont)	
LM End	3.24	Issue Type +	En	Location *		
Category	Supplemental			GPS Latitude/Longitude		
				Start	End	
Item	DWR UCIP Field Study			38.270151 °	38.270151 °	
				-121.705782 °	-121.705782 °	
DWR ID						
Comment Code						
Inspector Comment						
FS_ID:18723						
DS_ID:22064						
EP_NO: N/A						
Repair Type: Non-Urgent						
Crossing Status: Indicator Found						
UCIP Comments: Only a CMP riser was found on WS.						
FIELD_STRUCT_DESC: 36-inch asbestos bonded steel irrigation						
discharge pipe through the levee, 15 feet below the crown, not found.						
Slide gate in a corrugated metal pipe (CMP) riser on the waterside (WS)						
slope, found. Pump in pump house on a pile structure in the stream, not						
found. Service pole and anchor on the landside (LS) slope, not found.						
FS Date: 8/15/2013

WS view: closer view of slide gate in CMP riser.

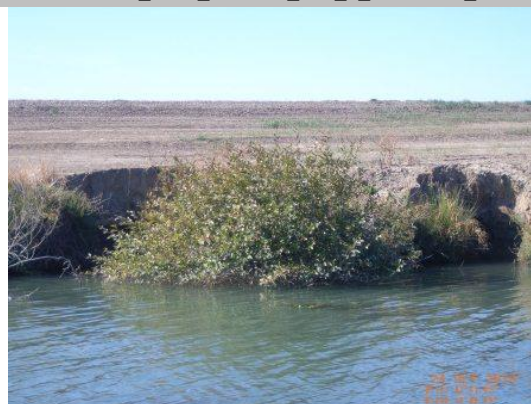
Photo 1 of 1 : SP_2018_RD2060_243_2_20180305_00002.jpg

LM Start	3.78	Rating **	A/W	Issue No.	2
LM End	4.09	Issue Type +	Ma	Location *	WS
Category	Supplemental			GPS Latitude/Longitude	
				Start	End
Item	2015 USACE Erosion Survey, DRAFT			38.264585 °	38.260593 °
				-121.698868 °	-121.696403 °
DWR ID	DWR_RD2060_03_s_2016_2				
Comment Code					
Inspector Comment					
2011 - Several pockets of erosion from rotational failure and slumping toe. 2013 - Site extended downstream to include new erosion pockets. 2015: No observed changes. [2015 Site ID: CHS_21-1_R]

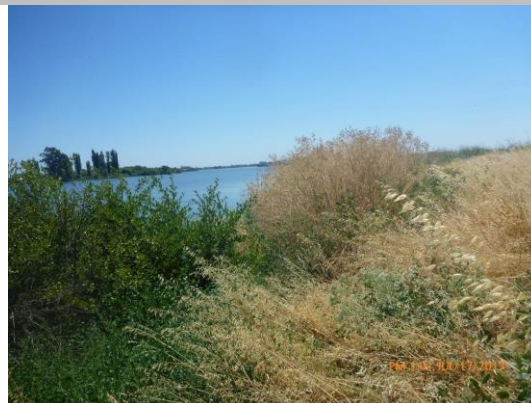
Photo 1 of 3 : SP_2018_RD2060_243_40_20180305_00076.jpg

LM Start	3.82	Rating **	A/W	Issue No.	40
LM End	3.94	Issue Type +	Ma	Location *	
Category	Supplemental			GPS Latitude/Longitude	
				Start	End
Item	2017 Storm Damage			38.264006 °	38.262364 °
				-121.698811 °	-121.698103 °
DWR ID	DWR_RD2060_03_f _ 2017_40				
Comment Code					
Inspector Comment					
Levee Evaluation Comments					
Description:Erosion commences approximately halfway down the slope and results in sloughing into the waterside toe. Existing rip rap has been pulled off the slope at this site					
Site ID No:410					
Site Designation:LMA-237					
Repair Type: Erosion					
Rating:Serious					
Field Date:7/18/2017					
Notes: This site is combined with LMA-234. There is minor toe erosion along whole 631 lf, but there is a 20' wide deep erosion at 38.26347, -121.69859. That is the only location that is serious and is likely due to a collapsed beaver den.

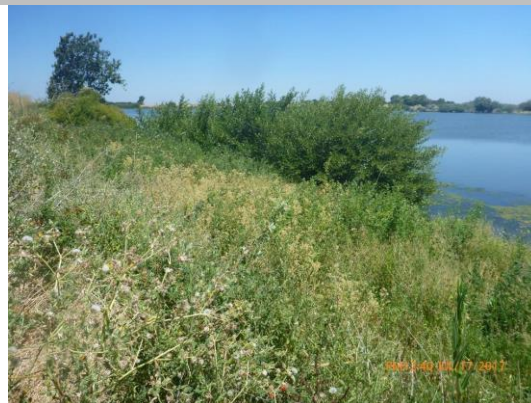
Photo 2 of 3 : SP_2018_RD2060_243_41_20180305_00080.jpg

LM Start	3.96	Rating **	A/W	Issue No.	41 (cont)
LM End	4.00	Issue Type +	Ma	Location *	
Category	Supplemental			GPS Latitude/Longitude	
				Start	End
Item	2017 Storm Damage			38.262114 °	38.261583 °
				-121.697978 °	-121.697647 °
DWR ID	DWR_RD2060_03_f_2017_41				
Comment Code					
Inspector Comment					
Levee Evaluation Comments					
Description:Erosion commences approximately halfway down the slope and results in sloughing into the waterside toe.					
Site ID No:411					
Site Designation:LMA-238					
Repair Type: Erosion					
Rating:Serious					
Field Date:7/18/2017					
Notes: This site includes LMA-235. Wide erosion looks like several small sited merged. Heavy veg indicates slow erosion.

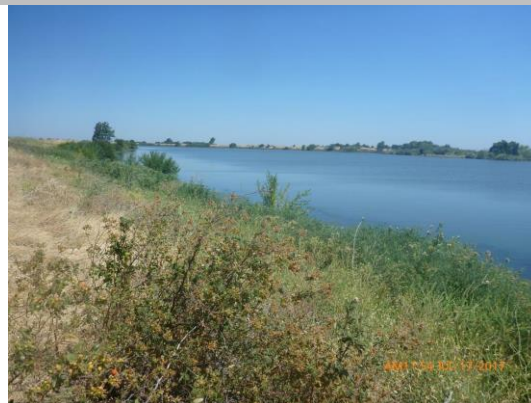
Photo 1 of 3 : SP_2018_RD2060_243_42_20180305_00082.jpg

LM Start	4.06	Rating **	A/W	Issue No.	42
LM End	4.08	Issue Type +	Ma	Location *	
Category	Supplemental			GPS Latitude/Longitude	
				Start	End
Item	2017 Storm Damage			38.260789 °	38.260644 °
				-121.696964 °	-121.696828 °
DWR ID	DWR_RD2060_03_f _ 2017_42				
Comment Code					
Inspector Comment					
Levee Evaluation Comments					
Description:Erosion commences approximately halfway down the slope and results in sloughing into the waterside toe. Existing rip rap has been pulled off the slope at this site.					
Site ID No:412					
Site Designation:LMA-239					
Repair Type: Erosion					
Rating:Serious					
Field Date:7/17/2017					
Notes: Small erosion. Appears that site grows slowly with each high water. The center of the eosion is a deep cut that extends below rhe waterline. Possible beaver den collapse.

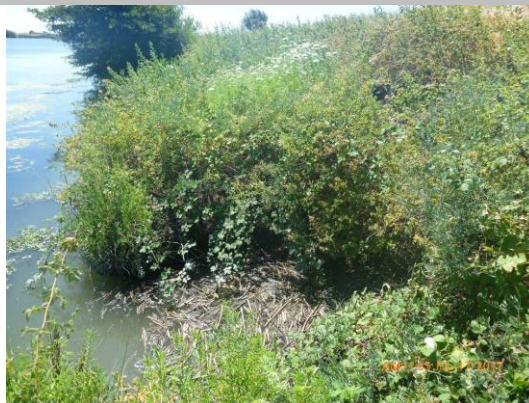
Photo 3 of 3 : SP_2018_RD2060_243_42_20180305_00084.jpg

LM Start	4.06	Rating **	A/W	Issue No.	42 (cont)							
LM End	4.08	Issue Type +	Ma	Location *								
Category	Supplemental		GPS Latitude/Longitude									
			Start	End								
Item	2017 Storm Damage		38.260789 °	38.260644 °								
			-121.696964 °	-121.696828 °								
DWR ID	DWR_RD2060_03_f_2017_42											
Comment Code												
Inspector Comment												
Levee Evaluation Comments Description: Erosion commences approximately halfway down the slope and results in sloughing into the waterside toe. Existing rip rap has been pulled off the slope at this site. Site ID No: 412 Site Designation: LMA-239 Repair Type: Erosion Rating: Serious Field Date: 7/17/2017 Notes: Small erosion. Appears that site grows slowly with each high water. The center of the erosion is a deep cut that extends below the waterline. Possible beaver den collapse.

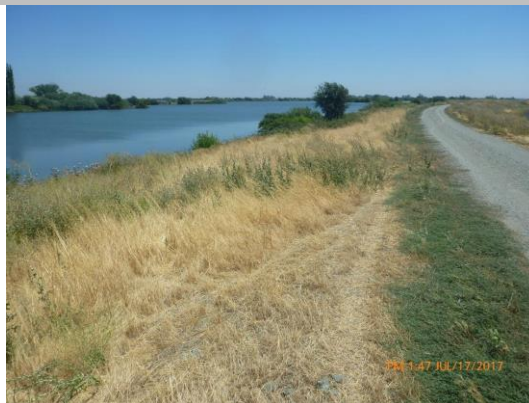
Photo 1 of 3 : SP_2018_RD2060_243_43_20180305_00085.jpg

LM Start	4.06	Rating **	A/W	Issue No.	43							
LM End	4.08	Issue Type +	Ma	Location *								
Category	Supplemental		GPS Latitude/Longitude									
			Start	End								
Item	2017 Storm Damage		38.260789 °	38.260644 °								
			-121.696964 °	-121.696828 °								
DWR ID	DWR_RD2060_03_f_2017_43											
Comment Code												
Inspector Comment												
Levee Evaluation Comments Description: Erosion commences approximately halfway down the slope and results in sloughing into the waterside toe. Site ID No: 409 Site Designation: LMA-236 Repair Type: Erosion Rating: Area of Concern Field Date: 7/18/2017 Notes: 3' cut to slope down to water, with a 50' deep cut. Heavy veg suggests slow progression of erosion.

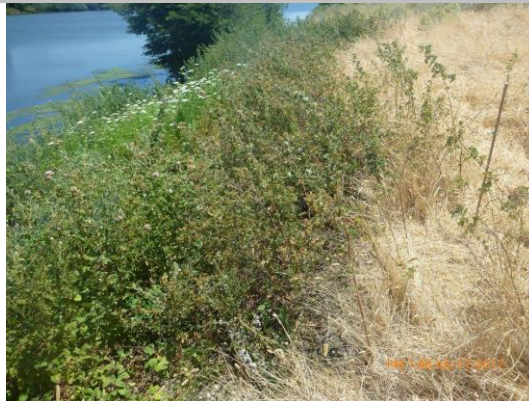
Photo 2 of 3 : SP_2018_RD2060_243_43_20180305_00086.jpg

LM Start	4.06	Rating **	A/W	Issue No.	43 (cont)
LM End	4.08	Issue Type +	Ma	Location *	
Category	Supplemental			GPS Latitude/Longitude	
				Start	End
Item	2017 Storm Damage			38.260789 °	38.260644 °
				-121.696964 °	-121.696828 °
DWR ID	DWR_RD2060_03_f_2017_43				
Comment Code					
Inspector Comment					
Levee Evaluation Comments					
Description:Erosion commences approximately halfway down the slope and results in sloughing into the waterside toe.					
Site ID No:409					
Site Designation:LMA-236					
Repair Type: Erosion					
Rating:Area of Concern					
Field Date:7/18/2017					
Notes: 3' cut to slope down to water, with a 50' deep cut. Heavy veg suggests slow progression of erosion.
